Morgan General Processing and Distribution Center

Morgan Station Mail Facility Case Study

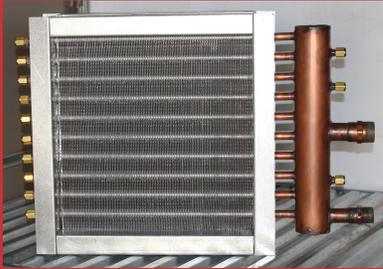
Steam Distributing Coil with Sentry Guard™ Option

Sentry Guard™ Burst Resistant Coils are designed with a thread able “plug” on every header, return bend and tube stub of the coil. The narrow plug incorporates a hex design making it easy to remove and replace without damaging the delicate copper tubes of a coil. When freezing occurs, pressure builds until the weakest part of the coil fails, usually above 1000 psig. The patented relief plugs installed with a Sentry Guard™ system are designed to burst at 650 psig, relieving pressure before coil damage occurs. Freeze severity determines how many relief plugs burst. If a freeze event occurs, repair is as simple as unscrewing the ruptured plugs and screwing on a replacement plug.

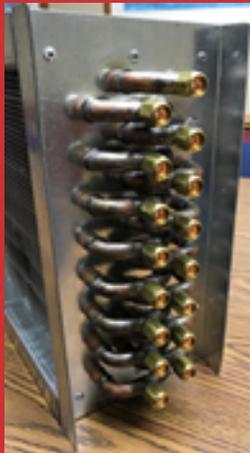
4 Row Chilled Water Coil with Sentry Guard™ Option
